**Inspection reference: 1234 Anywhere Avenue**

**Confidential Inspection Report**  
**1234 Anywhere Avenue**  
**My City VA 22222**

**February 5, 2018**

Prepared for:  
**New Homeowner**

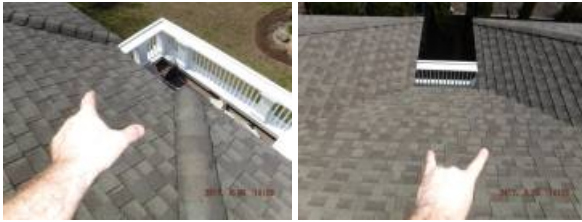
NOTE: Monitor left middle double valley as convergence of water will increase wear and tear.

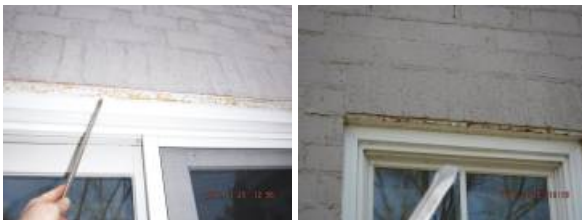
Brick (facade or solid) Observations- Cracking - Brick veneer or solid walls that have broken or have separations between courses are signs of settling or a more serious condition. (Typical settlement cracks noted right middle below upper window.)

**Attention Needed** - The lintels above the windows or doors are noted to have minor rust. The lintels need paint. The paint on lintels keeps the steel from deteriorating. Rust can cause swelling of the metal resulting in separations between courses of brick. (Noted for lintels for North facing windows.)

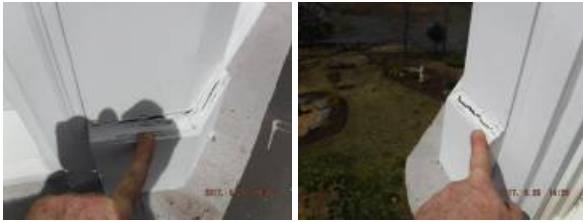
#### Condition of Painted Surfaces:

**Attention Needed** - The exposed painted surfaces need some minor attention or touch-ups to make the surfaces weathertight. These repairs should be scheduled soon to prevent further deterioration. (Noted at rear turret window trim - North facing sides.)

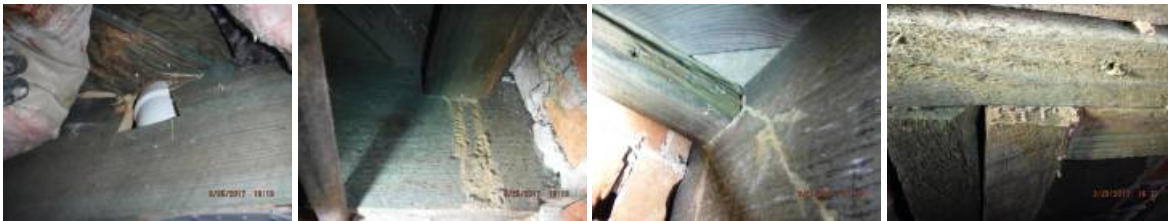
**Action Needed** - One or more floor joists were noted to have been cut or modified greater than 30%. This could contribute to structural movement and damages to home. We recommend further evaluation by a Qualified Licensed Building Contractor. (Located left front under Hall Shared toilet.)

**Action Needed** - One or more floor joists had evidence of WDO (Wood Destroying Organisms), such as termites, powder post beetles, carpenter ants. This inspection does not include a Termite report however does note if evidence was found. We recommend review of these areas and repair of any damages as needed by a Qualified Licensed Termite & Moisture Company prior to closing. (NOTE: Appears older and bait traps evident around home.) (Located front middle under fireplace and rear middle of original crawl.)

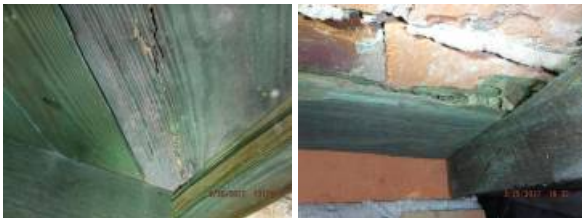
#### Sub-Flooring

**Action Needed** - One or more sub flooring had evidence of WDO (Wood Destroying Organisms), such as termites, powder post beetles, carpenter ants. This inspection does not include a Termite report however does note if evidence was found. We recommend review of these areas and repair of any damages as needed by a Qualified Licensed Termite & Moisture Company prior to closing. (NOTE: Appears older and bait traps evident around home.) (Located front middle under fireplace and rear middle of original crawl.)

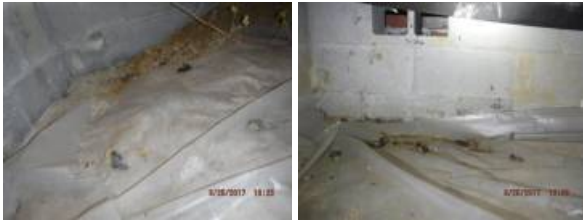
**Attention Needed** - Evidence of animal feces were located in crawl space. This indicated an entry point for animal into crawlspace and also incurs an unhealthy environment where animals urinate / defecate. We recommend further evaluation and correction by a Qualified Licensed Pest Control Service to seal entry point and remove fecal matter. (Located rear left under turret and right rear under master bath.)

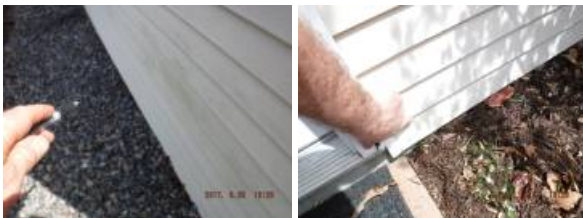
#### Garage Foundation:

**Attention Needed** - There does not appear to be adequate clearance between the earth and the wood siding or framing members of the structure. We recommend further evaluation by a Qualified Contractor to regrade around building.

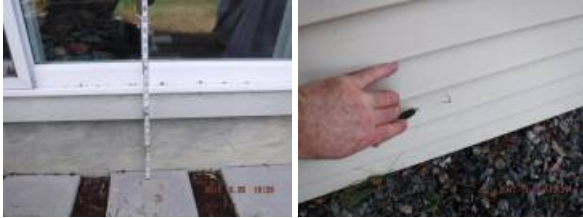
### Garage Exterior

**Attention Needed** - There is an unsafe condition at rear patio slider door. Door / patio was missing proper step or landing to allow for safe passage. This is a trip / fall hazard, we recommend further evaluation and correction by a Qualified Licensed Contractor.

**Attention Needed** - One or more areas of minor damage to siding were noted. This does not appear to be contributing to any interior damages. Monitor and repair as needed by a Qualified Licensed Contractor.
