**Inspection reference: 1234 Anywhere Avenue**

**Confidential Inspection Report**  
**1234 Anywhere Avenue**  
**My City VA 22222**

**February 5, 2018**

Prepared for:  
**New Homeowner**

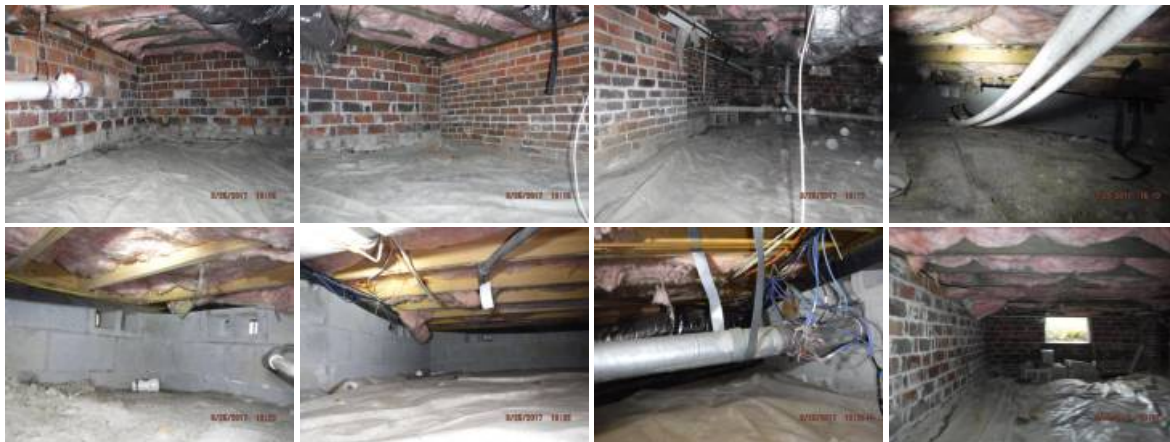
**NOTE:** Limited views of crawlspace were present due to one or more of the following (Insulation, ductwork, plumbing, electrical, framing or blocked areas) and could not be fully accessed for reviewed. Crawlspace reviewed from safe accessible areas and other areas not visible could not be commented on as to damages, if any present, nor are to be assumed as reviewed. We recommend if damages become evident that proper access be made and repairs by a Qualified Licensed Contractor be completed.

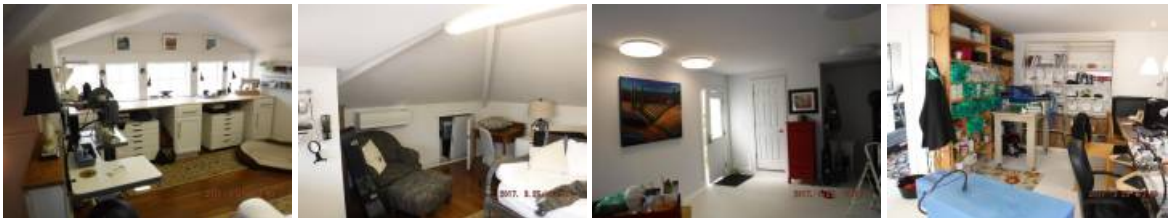
Due to stored items in the garage, I was unable to determine the condition of a portion of the walls hidden from view.

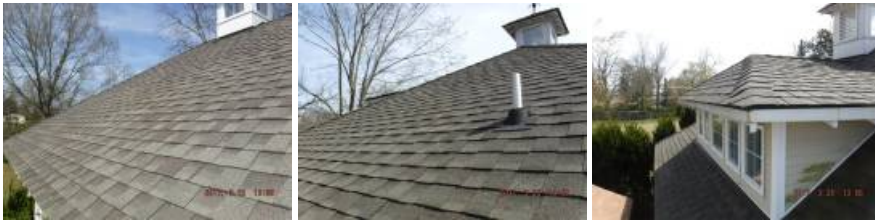
The detached garage roof covering materials are similar to that on the main structure, and they are in a similar condition.
